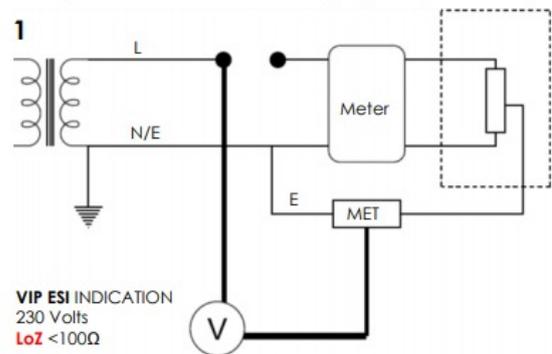
**Diagram 1** shows the VIP ESI with the main probe on the network side of the cut out fuse carrier and the passive probe is on the Main Earth Terminal (MET). The engineer would expect a voltage indication of 230V and a LoZ Light. The Low impedance measured is the earth fault loop. To

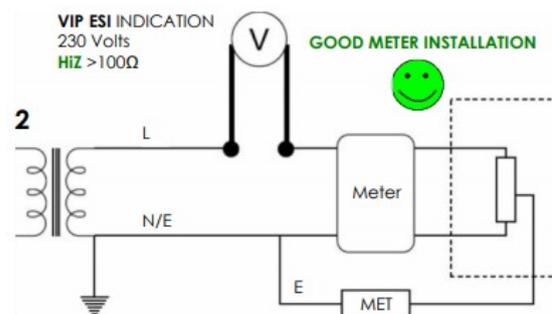
**Diagram 2** shows the VIP ESI with the main probe on the network side of the fuse carrier and the passive probe on the meter side of the fuse carrier (fuse removed). If the installed meter has been fitted correctly and there is no damage to any cables the engineer would expect a reading of 230V and a **GREEN HiZ** Light. This HiZ indication gives the engineer the piece of mind that there is no low impedance fault and that the cut out fuse can be refitted.

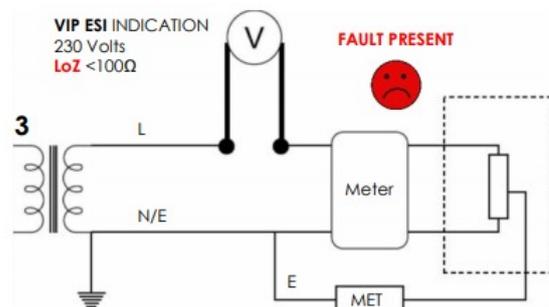
**Diagram 3** shows the VIP ESI in the same position as diagram 2 but in this case the meter installation has caused a low impedance fault (short circuit). Possibly caused by trapped / chaffing cables or cables that have come loose and made contact with the metal fuse box during the meter installation. In the case of a low impedance fault the engineer would see a voltage indication of 230V and a **RED LoZ** Light. This LoZ indication tells the engineer that it is not safe to refit the fuse as a potentially dangerous high fault current would flow. Further investigation would be required.
